6 PROCEEDINGS OF THE 1980 TRI-SERVICE
CONFERENCE ON CORROSION

5-7 NOVEMBER 1980
US AIR FORCE ACADEMY, COLORADO, Volume I.

CORROSION OF NAVAL SEA SYSTEMS
AN OVERVIEW

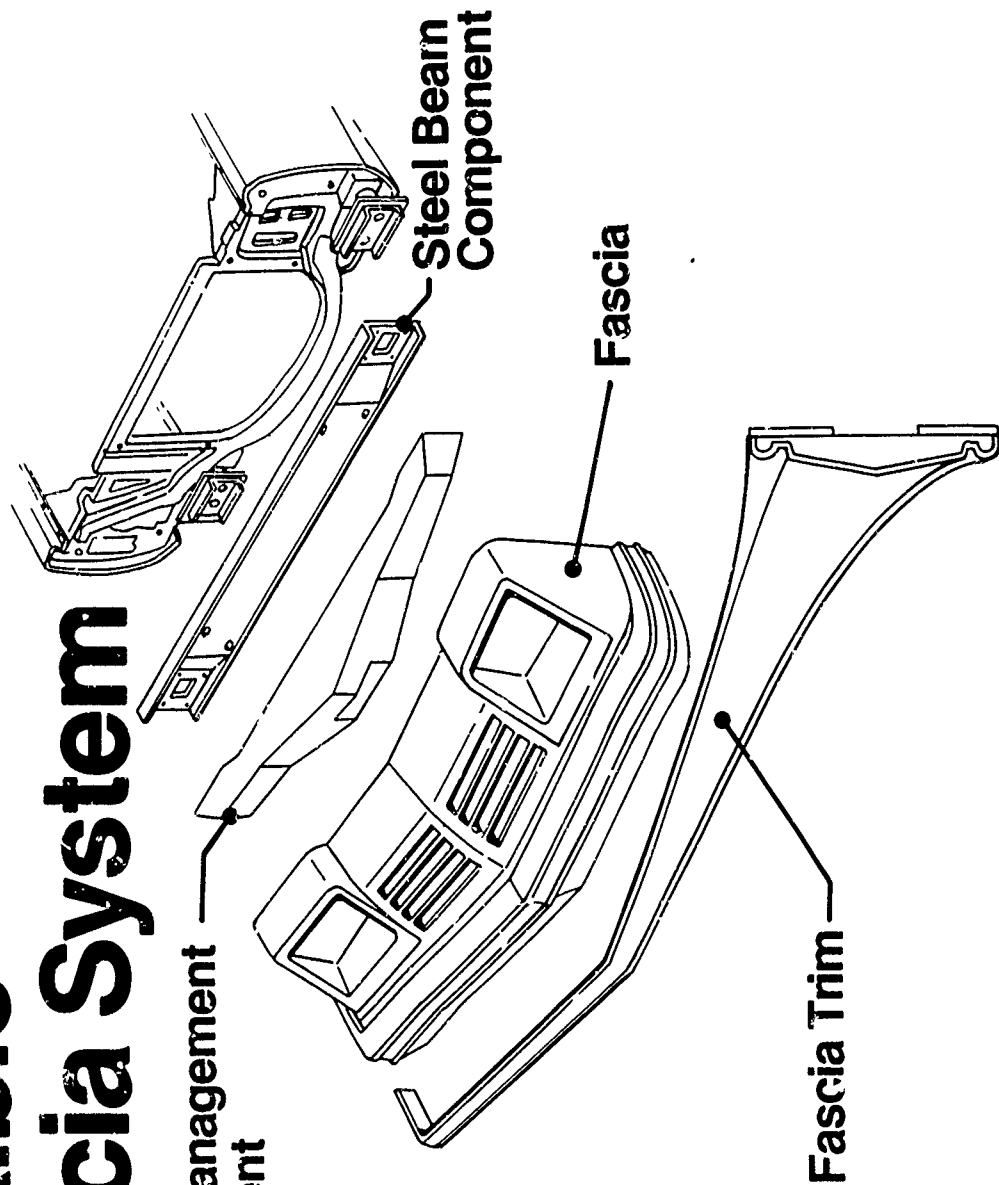
Illustration 51.

Flexible Fascia System

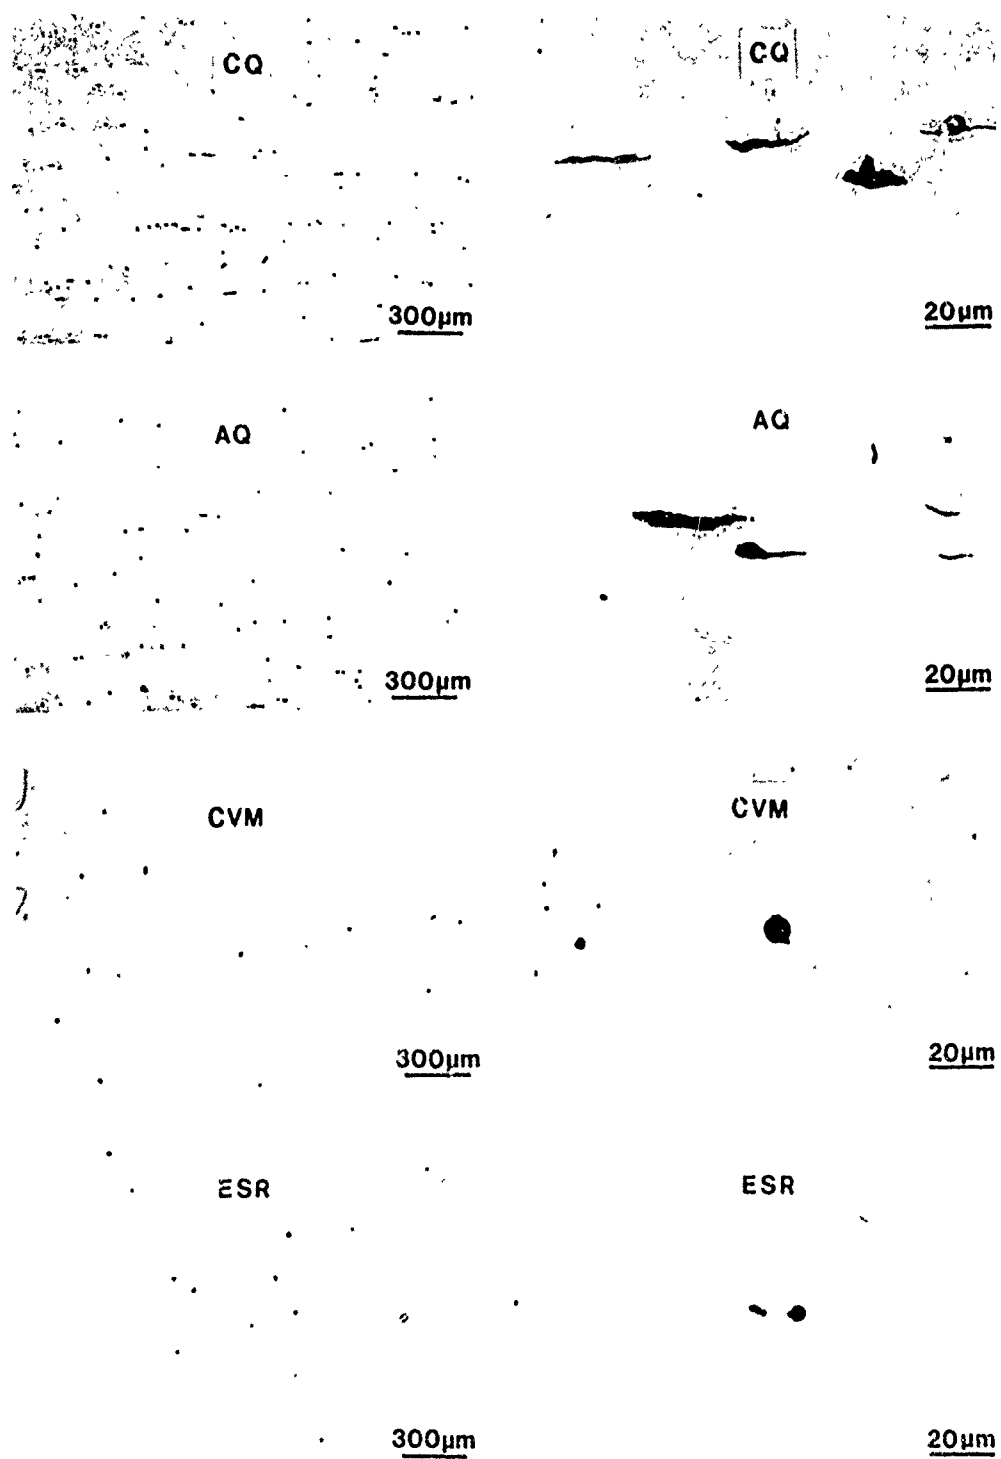
Figure 1. Optical Photomicrographs of Hot Rolled Type 4340 Steels, As Polished.

The differences in inclusion distribution among the steels are shown in the photomicrographs of as-polished samples in Figure 1. The observed differences were:

- a) The CQ steel contained a high density of large inclusions. The inclusions were elongated in the steel bar's hot rolling direction.
- b) The AQ steel contained a lower density of relatively large inclusions that were also elongated in the bar hot rolling direction.
- c) The CVM steel contained a low density of quite large spherical inclusions. At higher magnification, the spherical inclusions appeared to be made up of two different components, which was suggested by differences in optical reflectivity.
- d) The ESR steel contained a very fine dispersion of spherical particles.

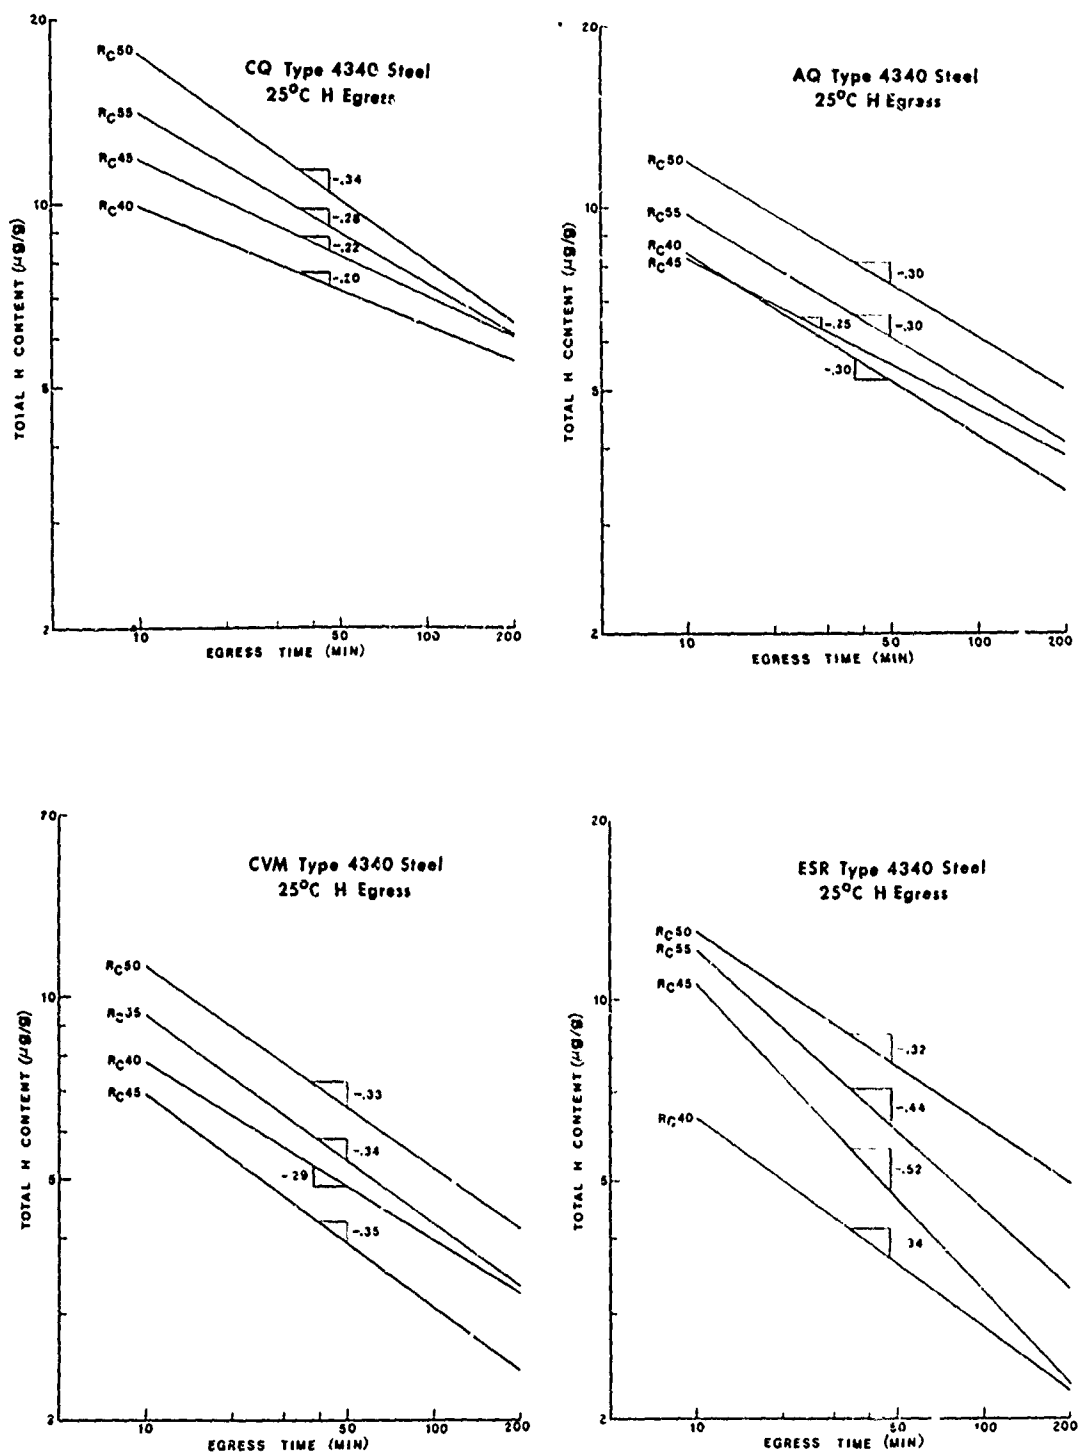
Figure 3. H Egress at 25°C from Cathodically Charged Type 4340 Steels.

The H egress results are presented as log-log plots of M , vs. t for each steel (CQ, AQ, CVM and ESR) at the four hardness levels, R 55, R 50, R 45 and R 40, in Figure 3 (25°C egress) and Figure 4 (100°C egress). The elevated temperature egress results for the CVM steel were not complete and, therefore were not included in Figure 4. The H egress results indicated that H behavior clearly depends on the steel grade (and thus chemistry) and hardness level (and thus microstructure).

A number of trends in H behavior are evident in the H egress results. First of all, the amount of H absorbed by each steel exhibits the same dependence on hardness, i.e., $M_H(R 50) > M_H(R 55) > M_H(R 45) > M_H(R 40)$. That trend is best indicated by comparing the M_H values obtained at the shortest egress time ($t_e = 10$ min) at the lower egress temperature (25°C) in Figure 3. Those values are plotted in Figure 5. In addition, the H content of the charged samples exhibits the same hardness dependence following 25°C egress (Figure 3). However, there is a reversal in $R_{c 55}$ and $R_{c 50}$ H content in the ESR and CQ steels following 100°C egress (Figure 4).

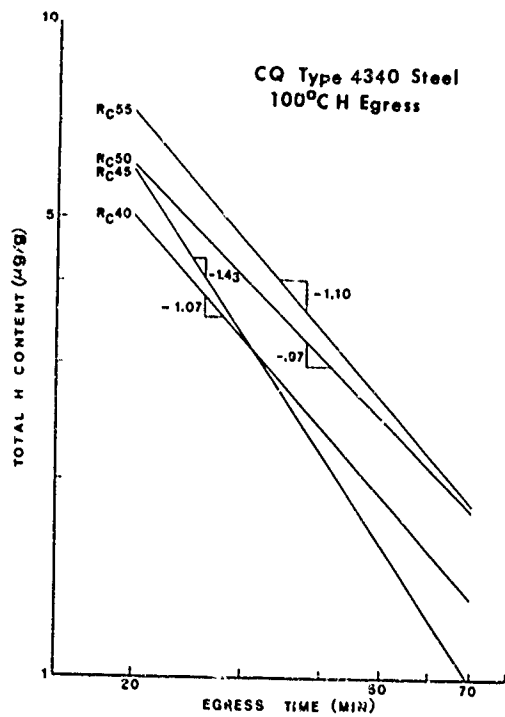
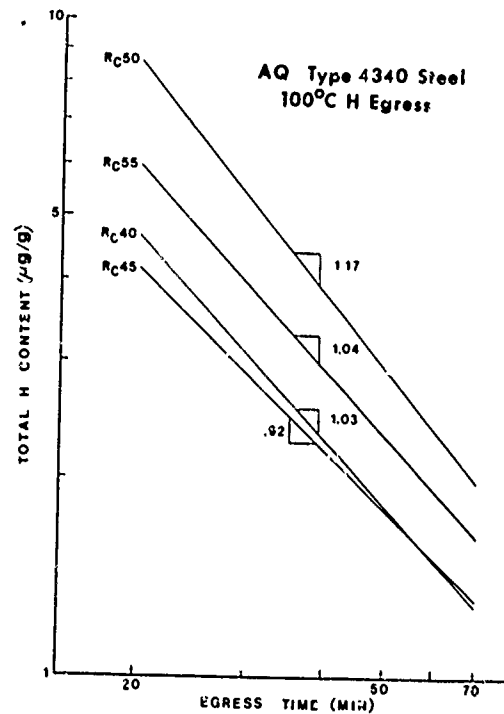
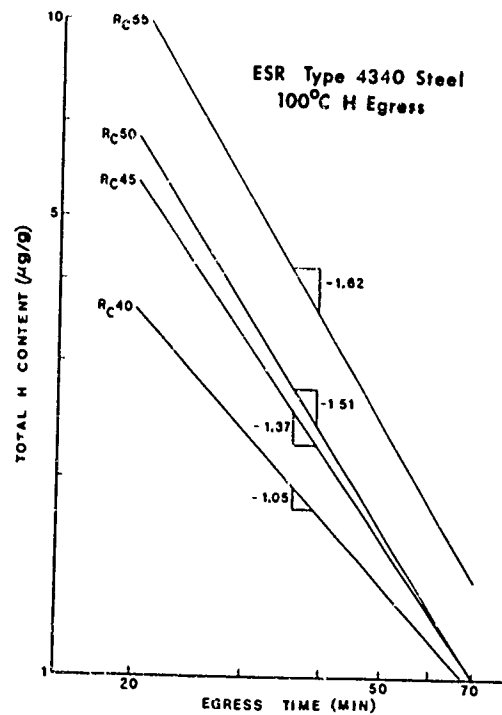
Figure 4. H Egress at 100°C from Cathodically Charged Type 4340 Steels.

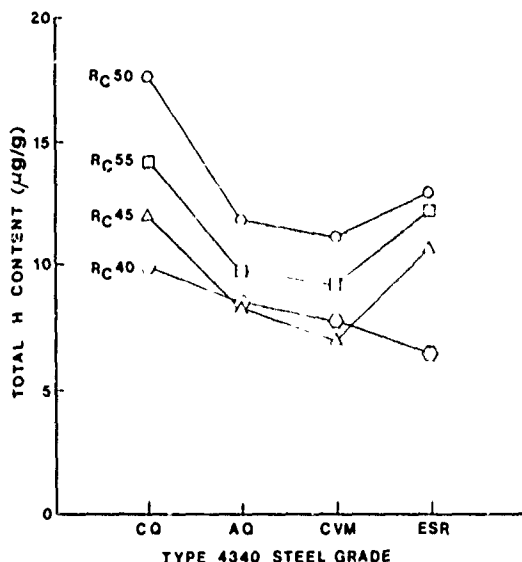
Figure 5. Total H Absorbed by Cathodically Charged Type 4340 Steels (Measured after 10 min. Egress at 25°C).

Another trend in H behavior is evident in Figure 5. The amount of H absorbed for a given hardness level was not the same for all the steel grades. At each hardness level, the H contained in the CQ steel was greater than that contained in the other three steels. The influence of steel grade was more pronounced after longer egress times. It is apparent in Figure 3 and, to a lesser degree, Figure 4, that after longer egress times, the H contained in the steels at each hardness level varied with steel grade according to the general trend: air melted grades (CQ and AQ) > remelted grades (CVM and ESR). That the trend is more pronounced at longer egress times suggests that it is the H egress rate, and not H absorption, that is most influenced by steel grade. The H egress rate dependence on steel grade is illustrated by comparing the 25°C and 100°C power law exponents, n (referred to as the H egress coefficients), for the steels as shown in Figure 6.

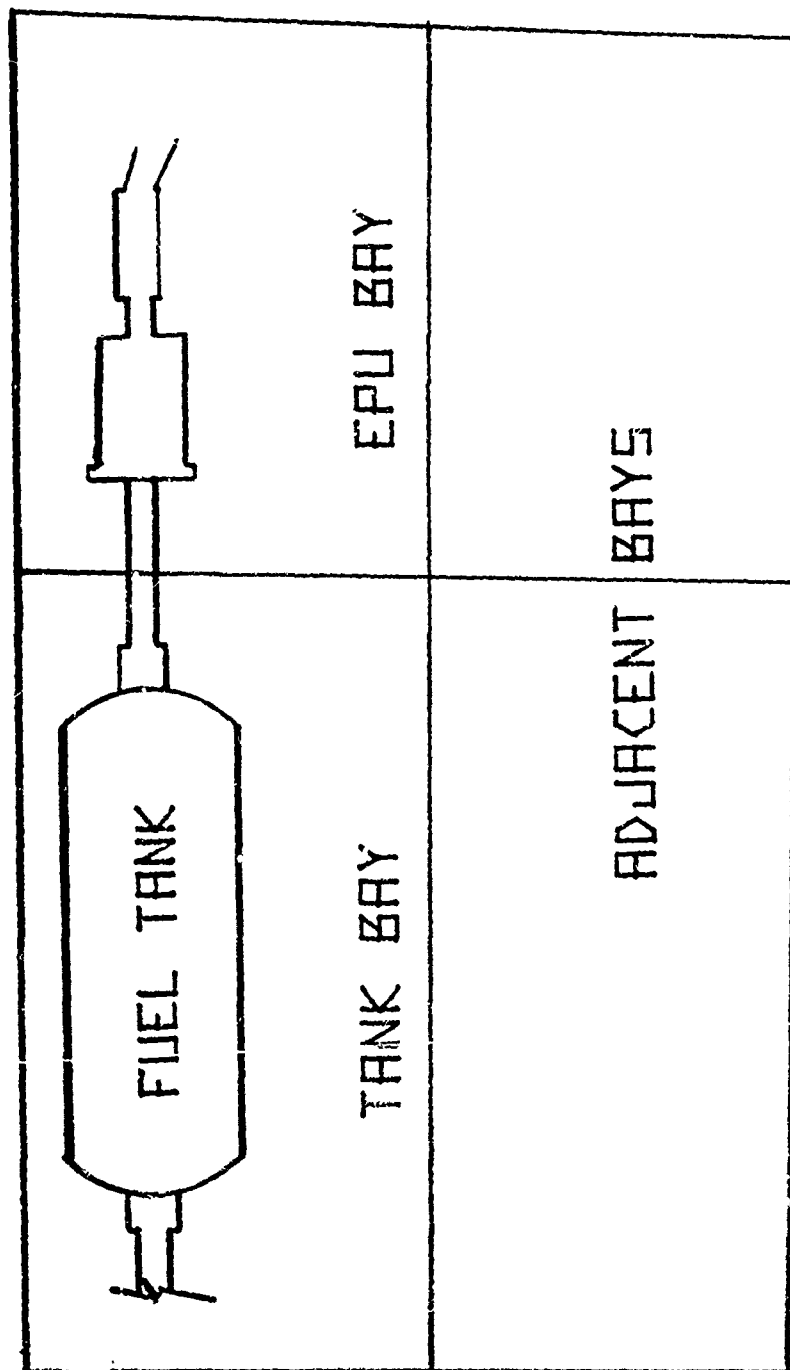
FIGURE 1

LOCATION OF HYDRAZINE COMPARTMENTS

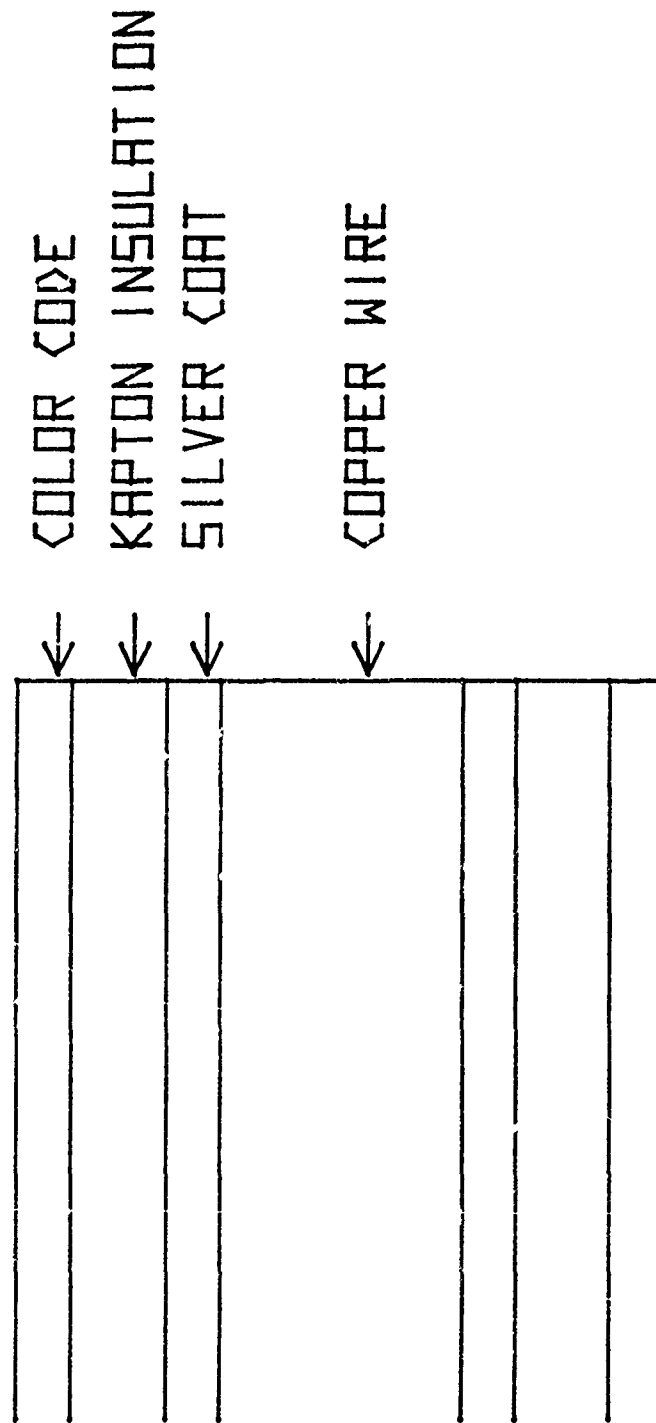
FIGURE 3

ATTACK OF KAPTON WIRES BY HYDRAZINE

After a total of five hours of exposure the Kapton began to disintegrate, exposing bare silver-coated copper wires. In the presence of moisture, electrical shorts were created. It was also noted that once a wiring harness was contaminated with hydrazine, it was virtually impossible to flush out with water. (A water flush is the only accepted way of cleaning up hydrazine spills on the airplane). For this reason even a short term contact of the wires with hydrazine could lead to the damage described. Teflon wires cannot be substituted for Kapton in many instances due to other property requirements.

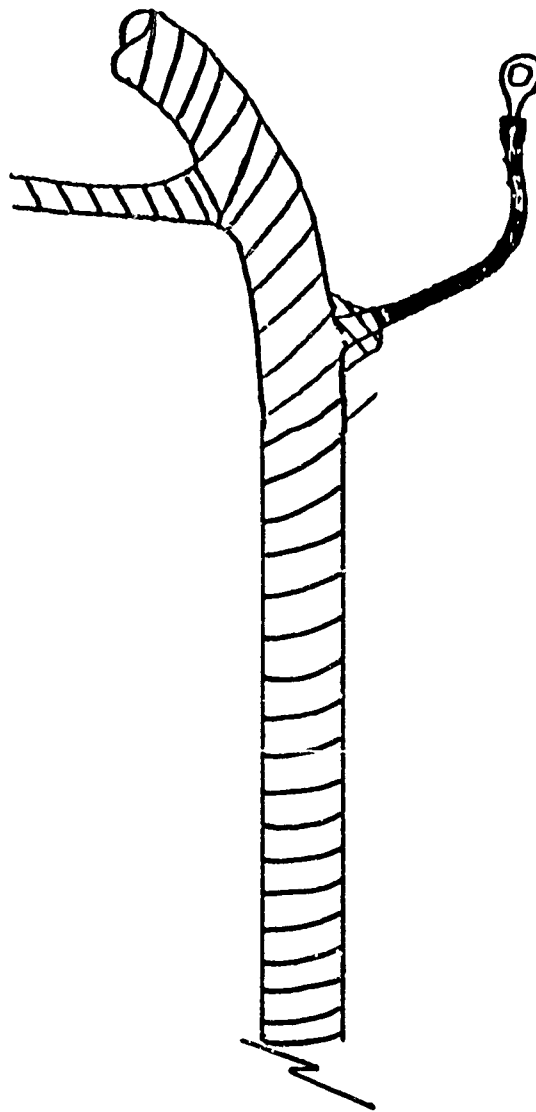
FIGURE 4

ELECTRICAL HARNESS WRAPPED WITH TAPE

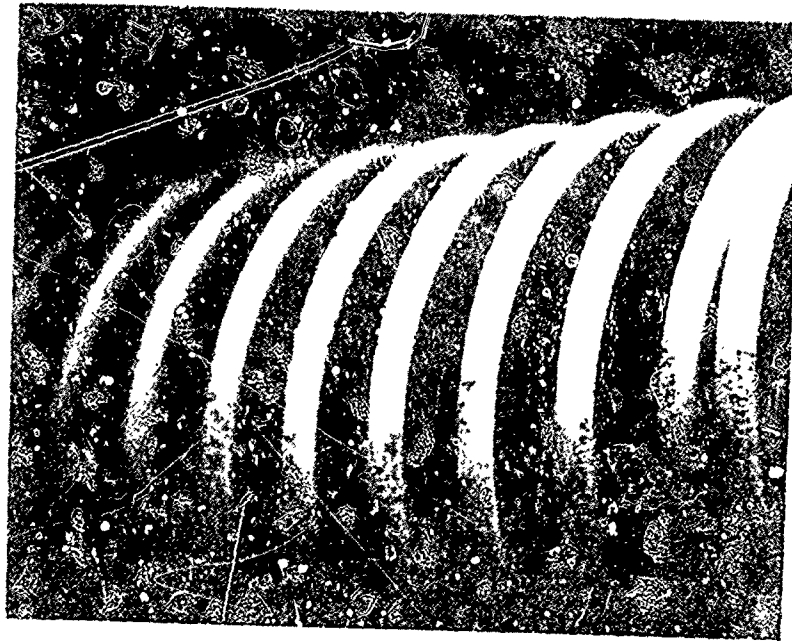
Figure 1. 20X impact switch spring.

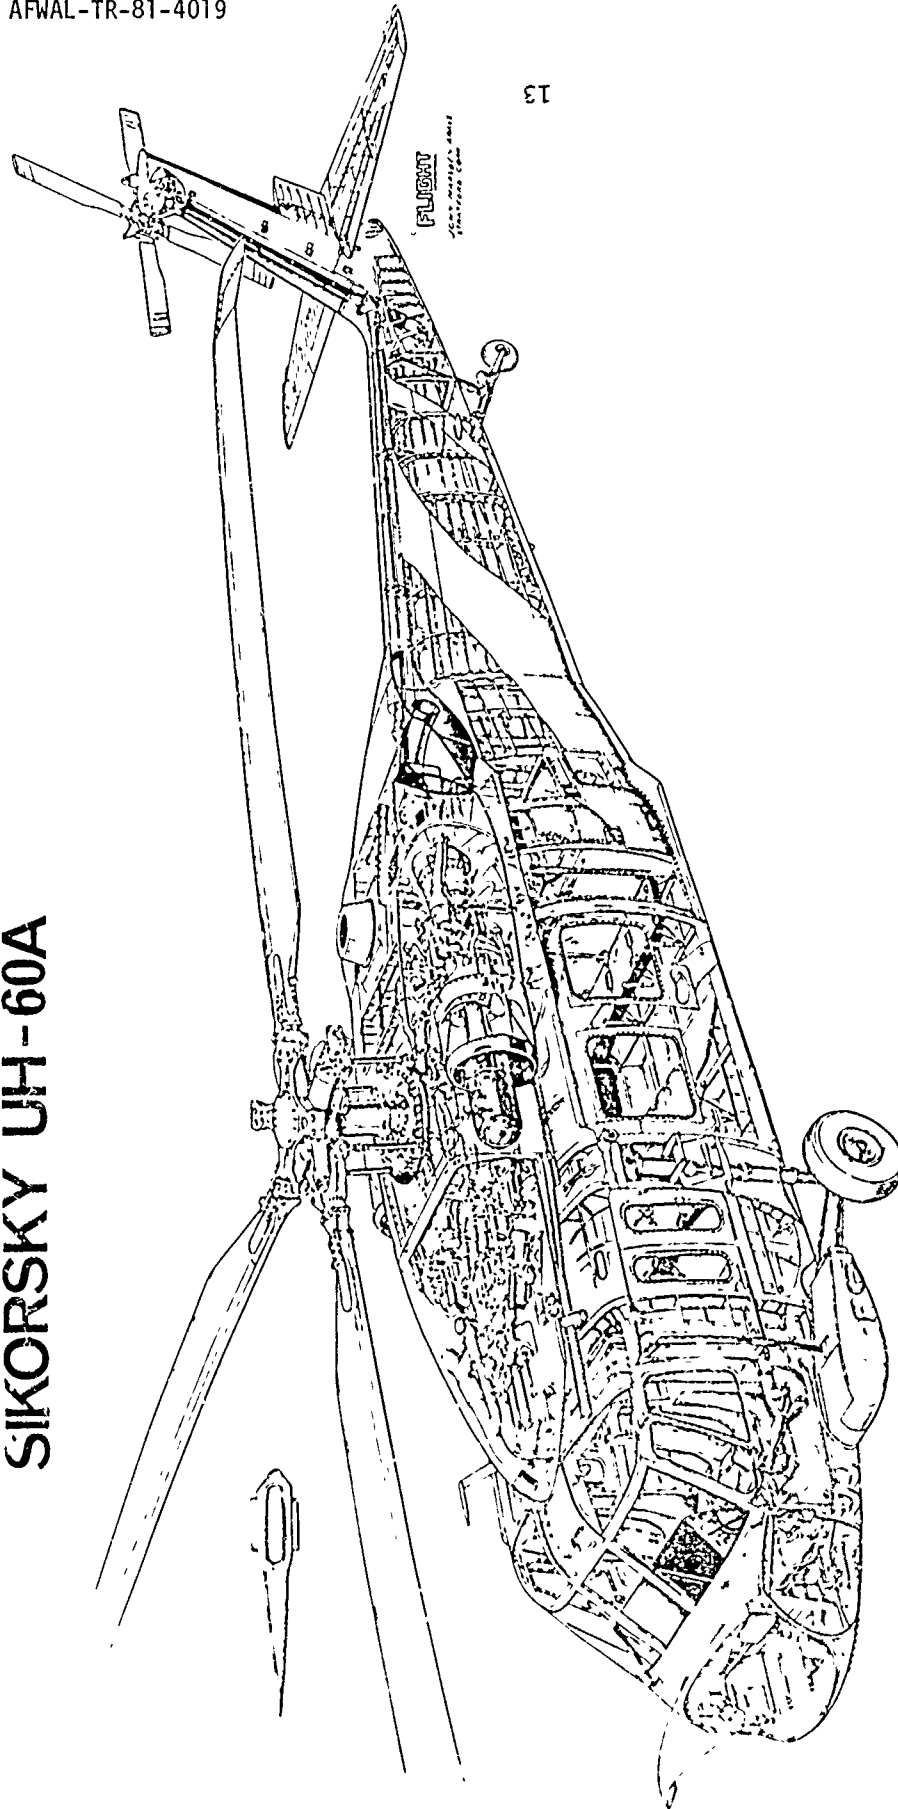
Fig. 1. The UH-60A BLACK HAWK helicopter.

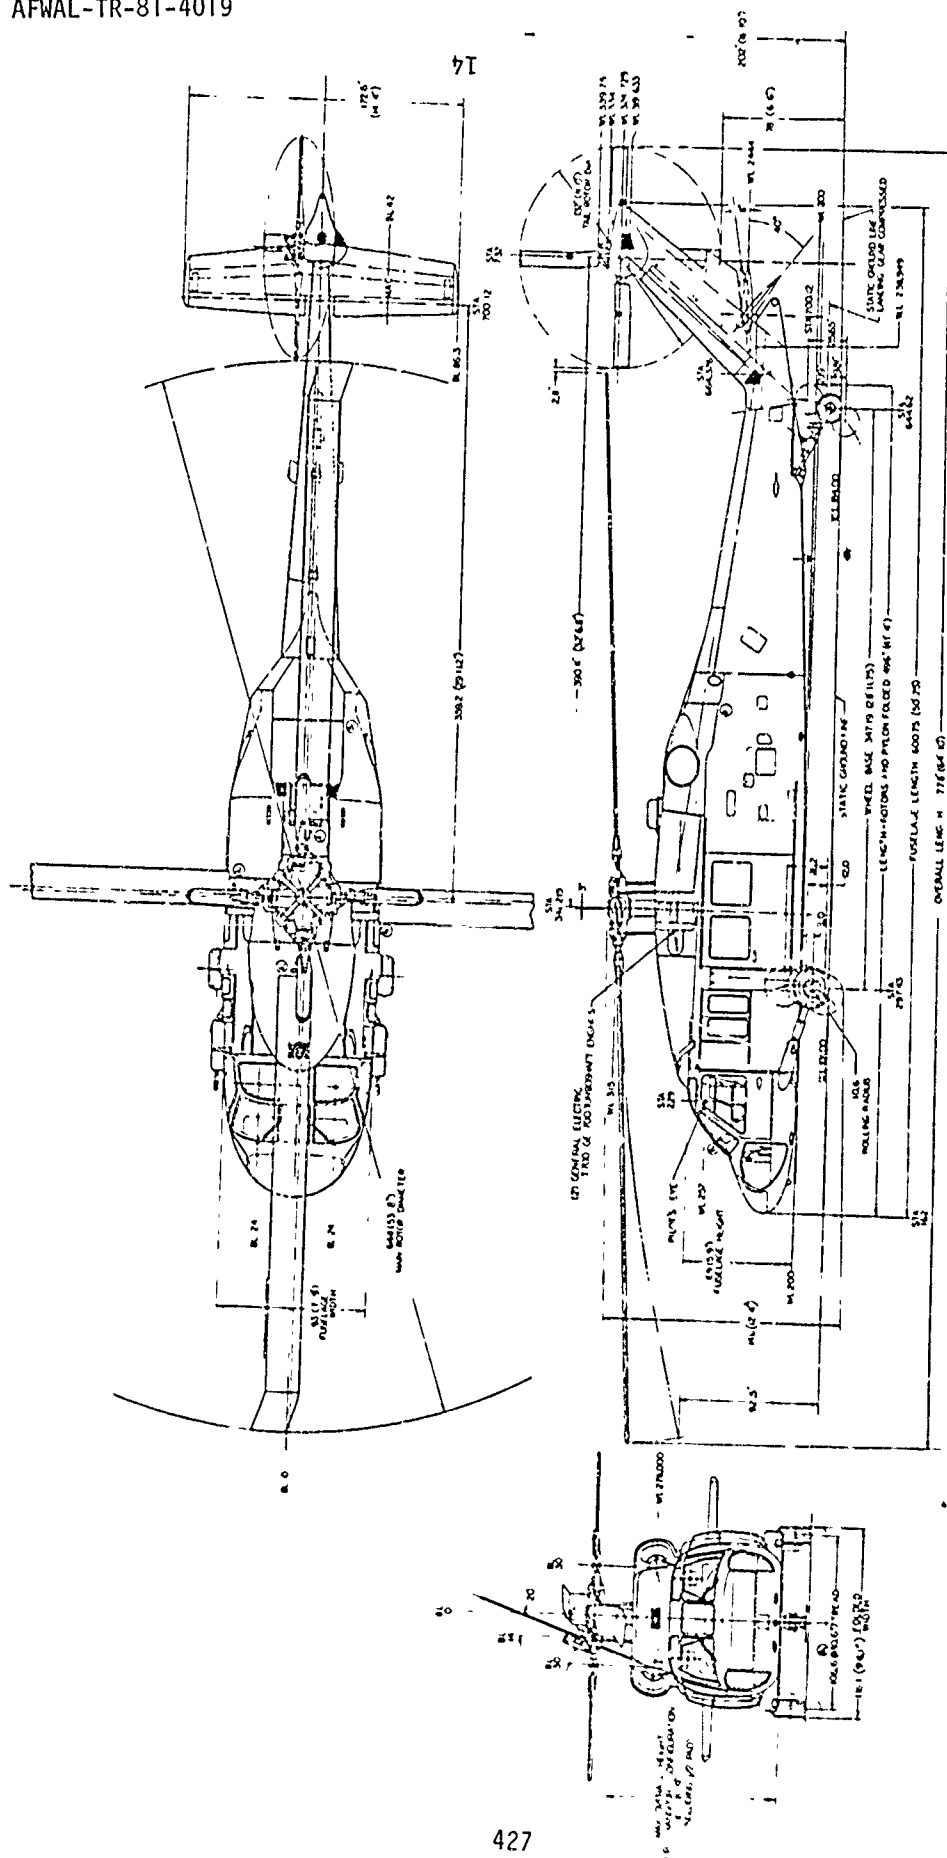
Fig. 2. Engineering diagrams of the BLACK HAWK helicopter.

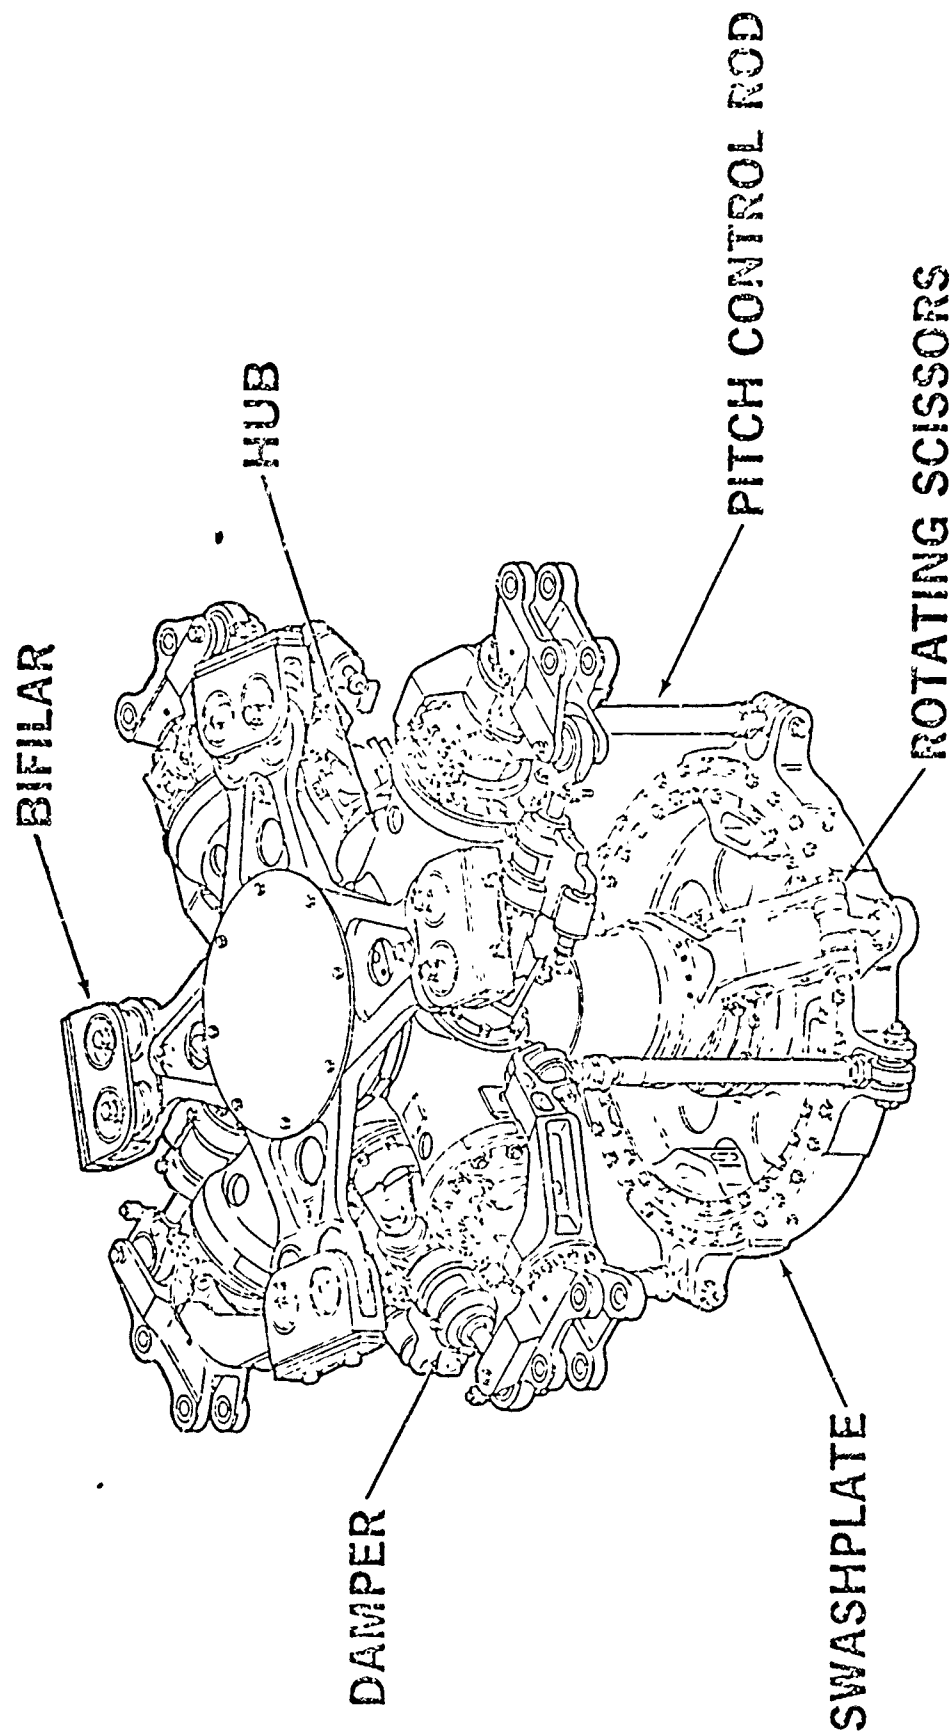
Fig. 3. The main rotor head assembly of the BLACK HAWK helicopter.

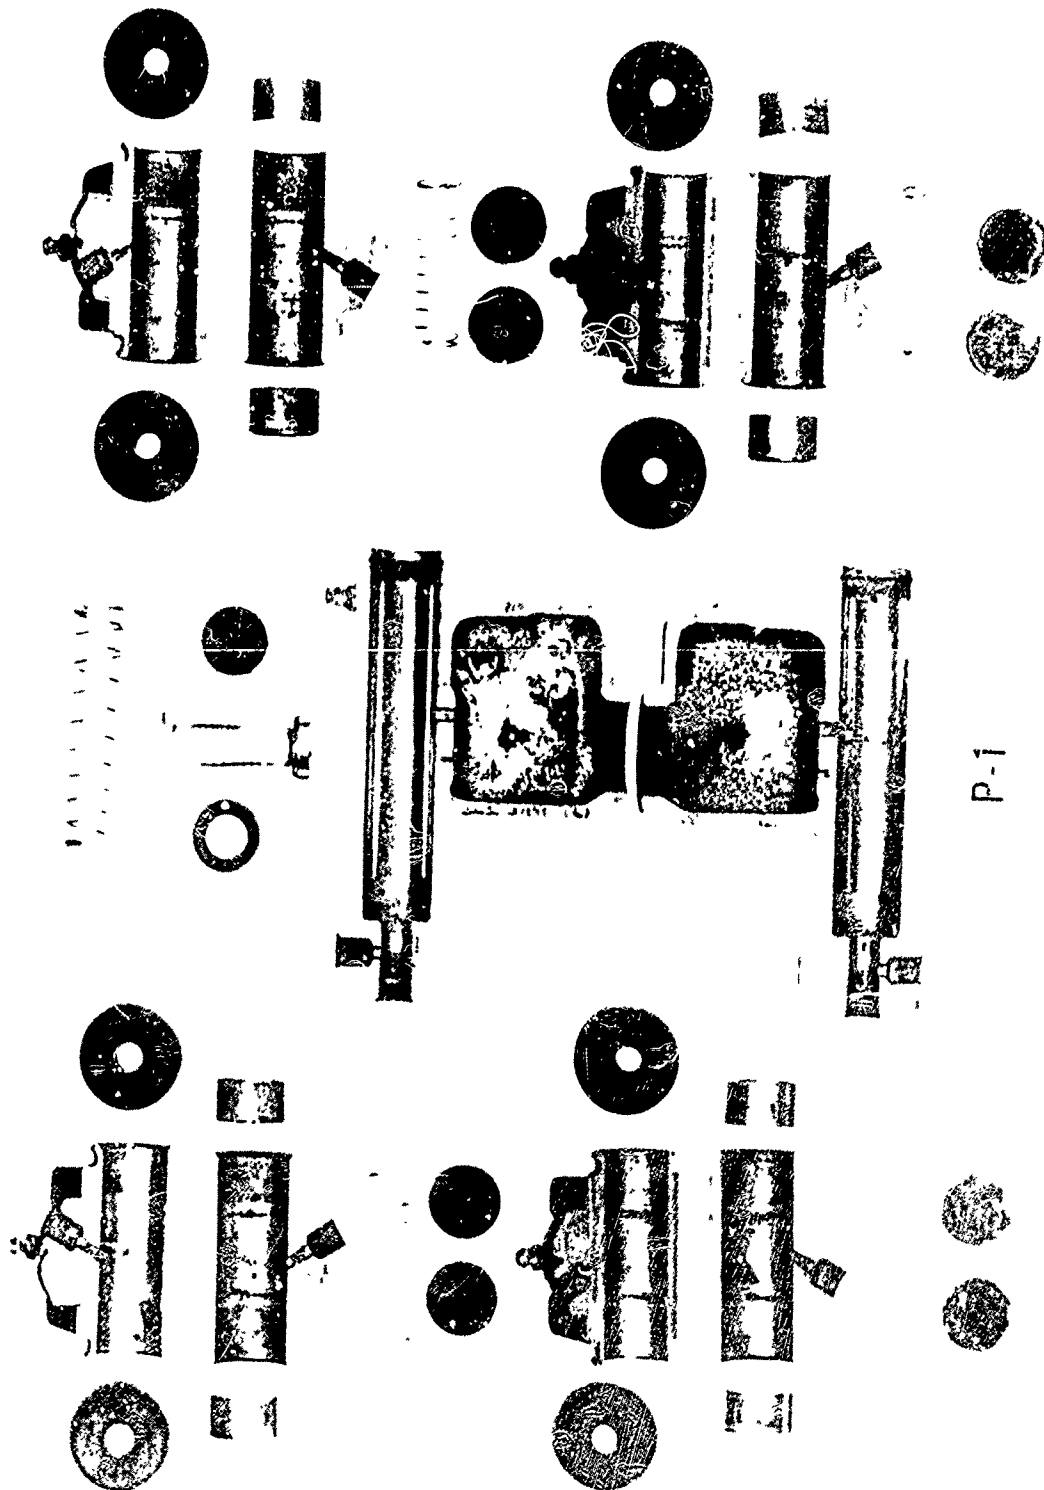
Figure 1 Typical set of cylinders after 2 years' operation at TTC with VV-B-680 fluid

The vehicles using the silicone fluids continued to operate trouble free during the second year. The cylinders with the two water intolerant fluids were satisfactory, with one fluid showing a tendency to stain and have slightly more corrosion of metal parts. The cylinders with the water tolerant silicone showed considerably more corrosion than those with the other silicones but were substantially better than those with the VV-B-680 fluid. The odor of gasoline and swelling of the secondary cup in the master cylinder were also noted in the 1 1/4-ton vehicles using the water intolerant silicones. It was not present in the vehicles using the water tolerant silicone. The rubber cups had a slight-to-moderate scoring and scuffing with all the fluids under test.

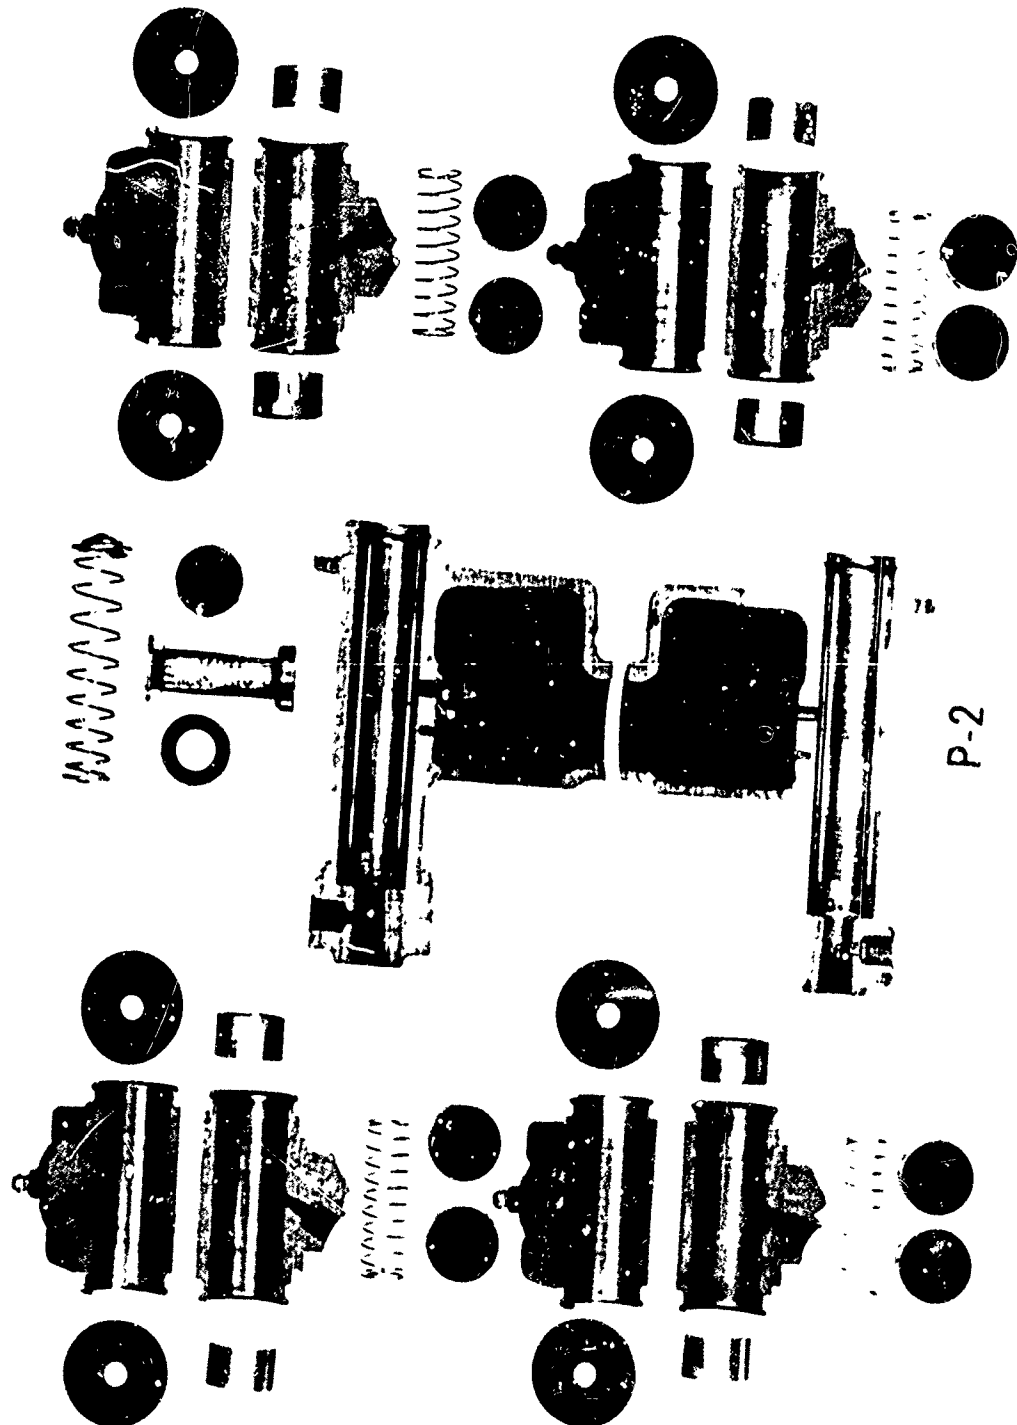
Figure 2 Typical set of cylinders after 2 years' operation at TTC with water-intolerant silicone.

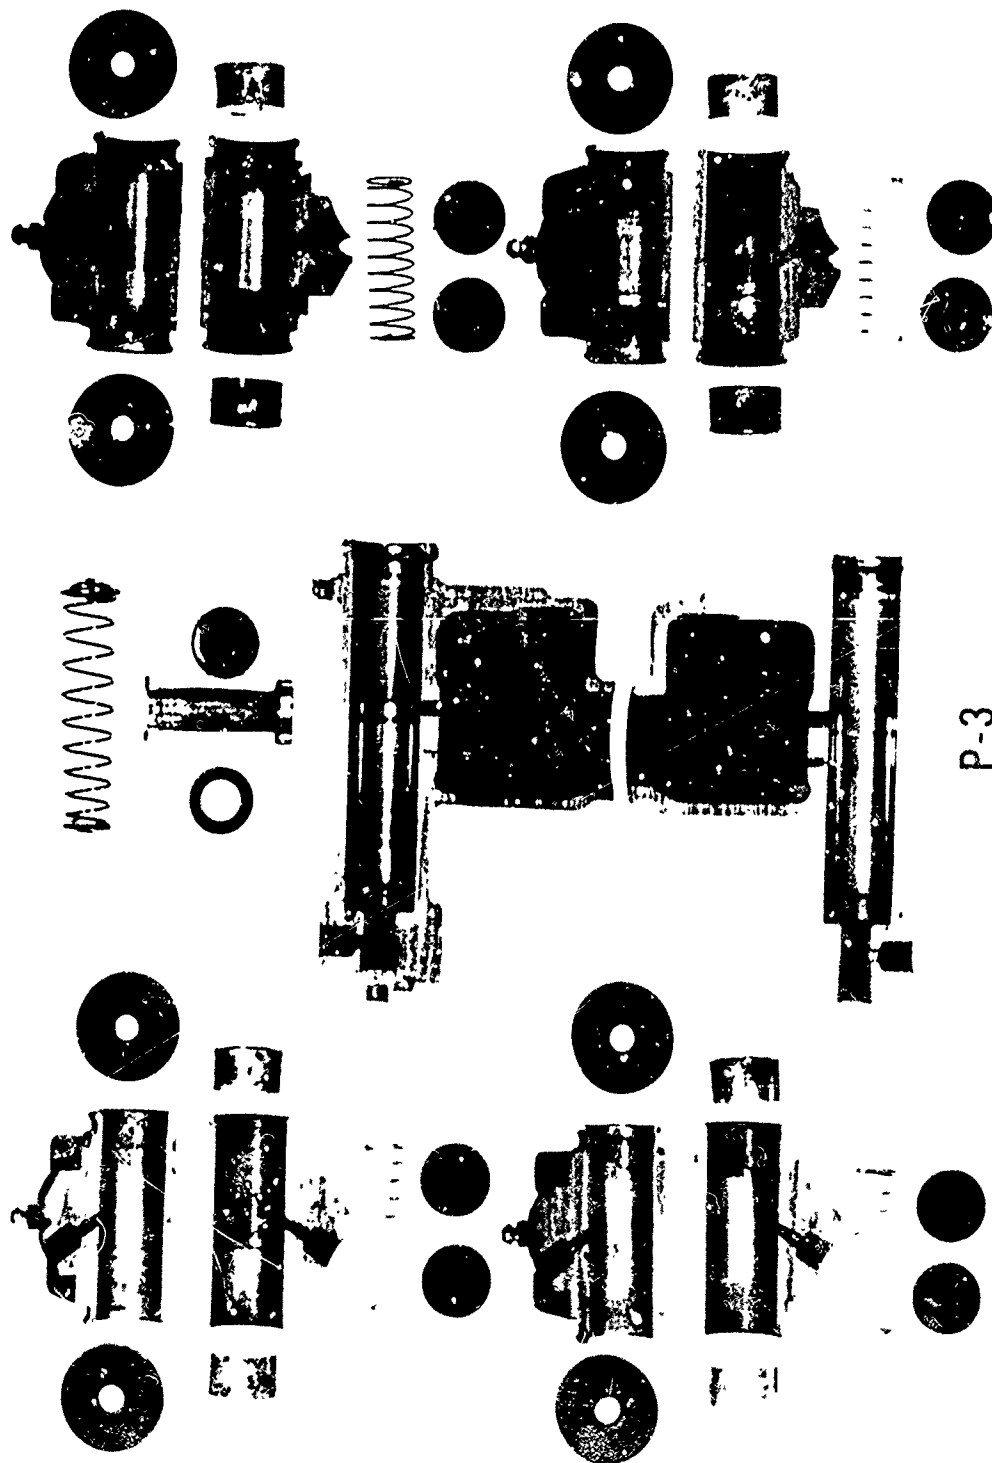
Figure 3 Typical set of cylinders after 2 years' operation at TTC with water-tolerant silicone

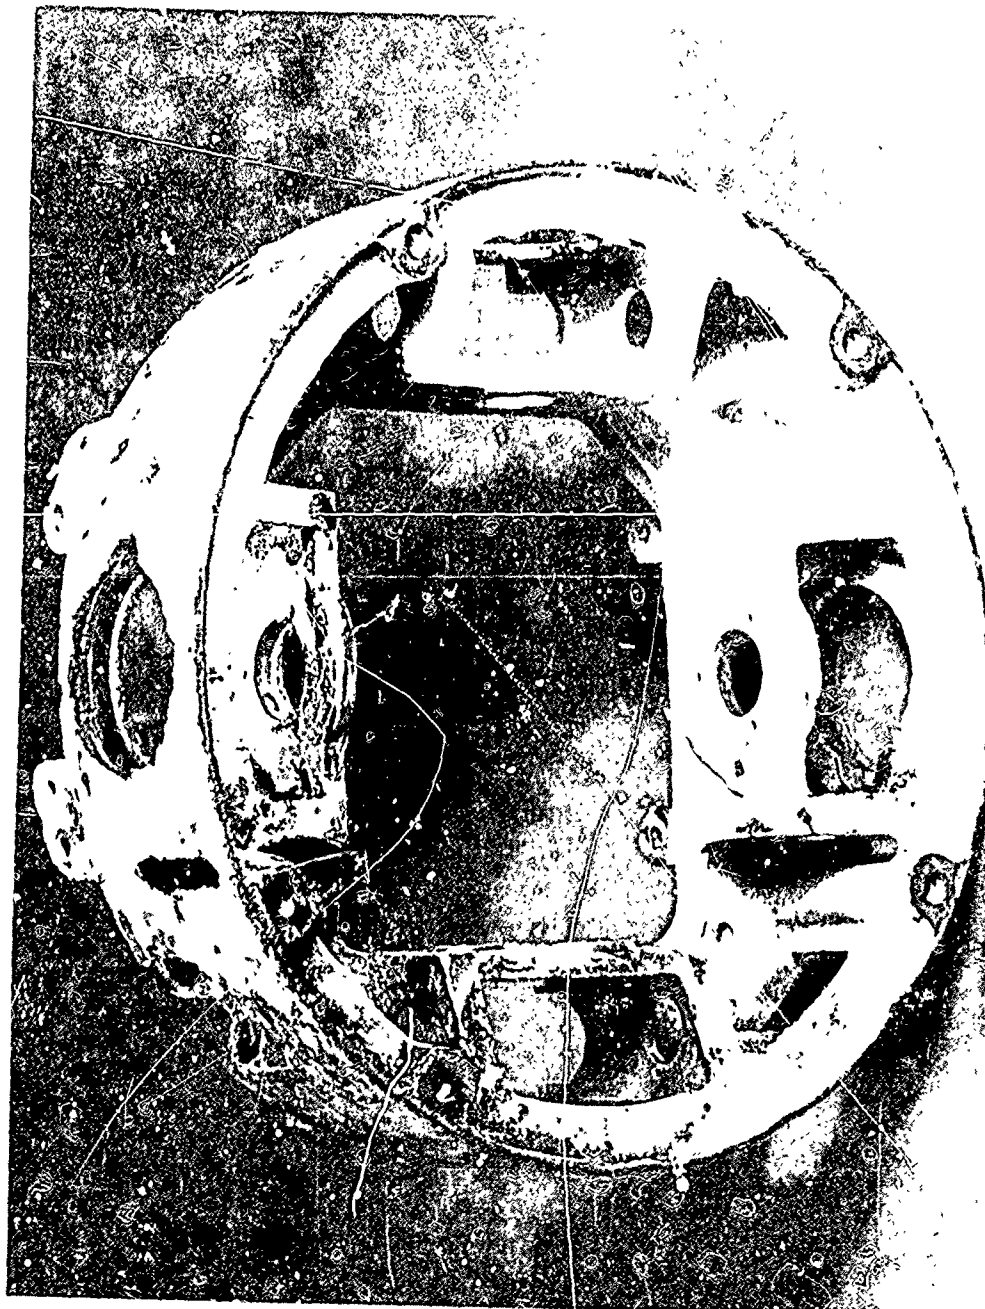
Equipment Miscellaneous, Magnesium Corrosion - Hawk Missile.

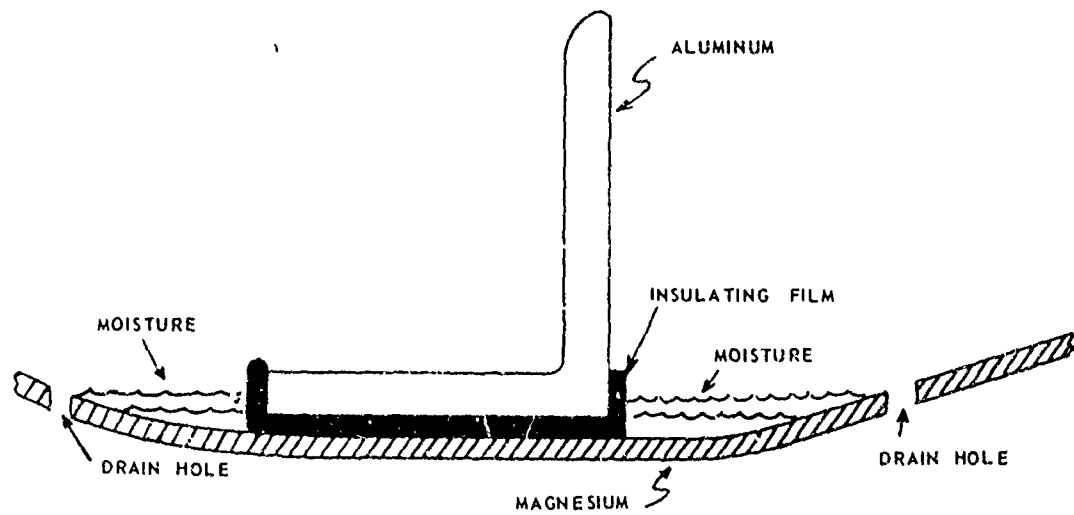
FIGURE 16. Elimination of Moisture Catchment Areas and Use of Drain Holes

(b) Insulating Film And Drain Hole Used To Prevent Moisture From Bridging Between Magnesium And Aluminum

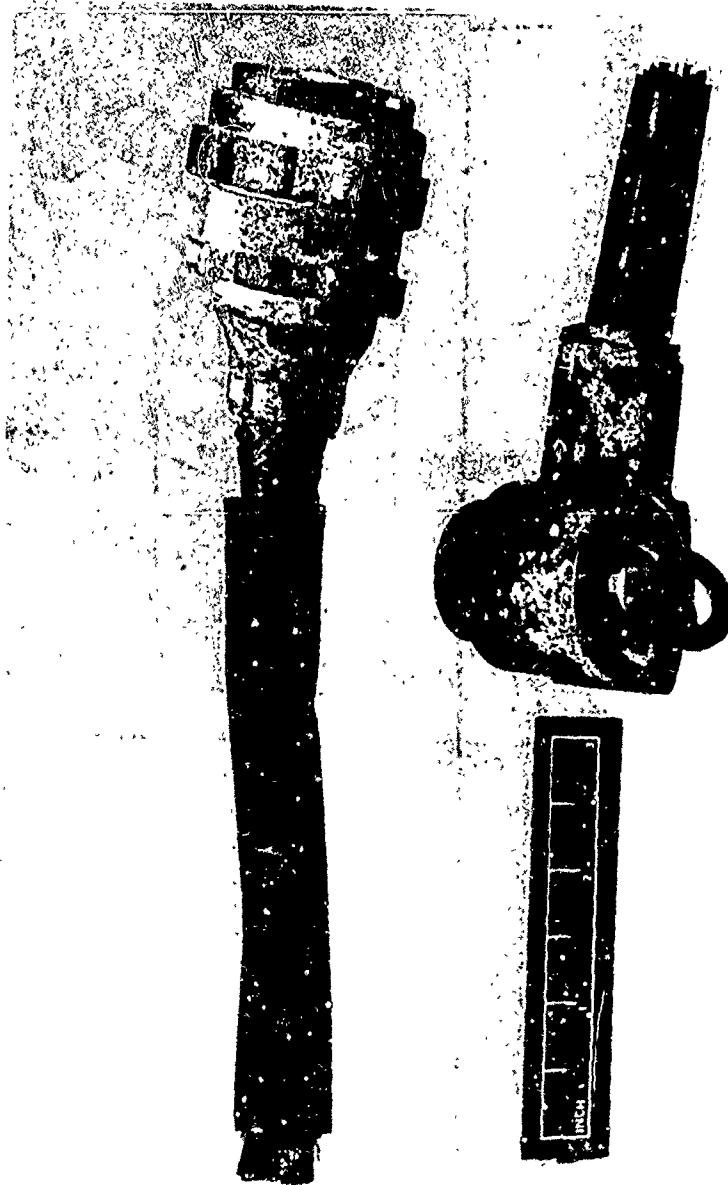
Electrical Connectors from Marine Corp Equipment Showing Effects of Halogen Pitting.
